# Phase I Environmental Site Assessment

Former Rincon Mushroom Farm APN 133-180-020 33777 Valley Center Road Valley Center, San Diego County, California 92082

Rincon San Luiseño Band of Mission Indians P.O. Box 68 Valley Center, California 92082 AUGUST 4, 2011

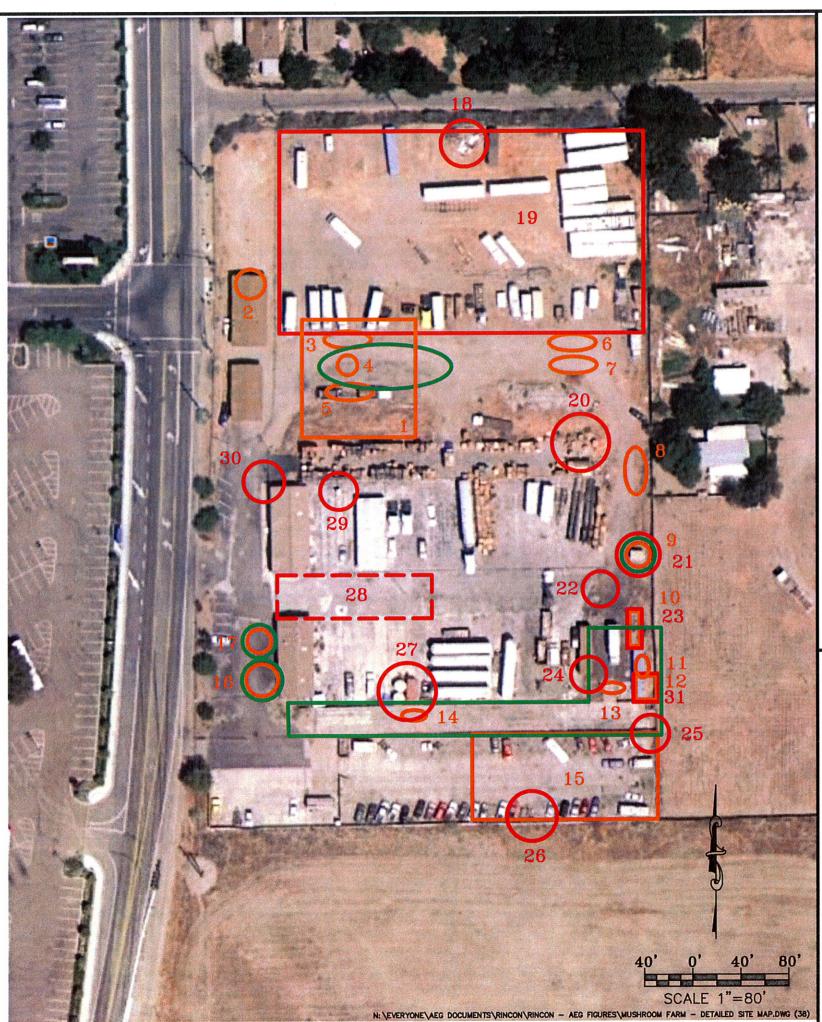
During the cleanup, ash was swept up, scooped up, and hauled from the Site, and the concrete surface was pressure washed. TPHd impacted soil was excavated and hauled from the Site. The TPHd impacted soil did not extend below a depth of 3+/feet above action levels. The areas of contamination observed, and areas cleaned up, during the USEPA 2008 investigation are shown on **Figure 5**.

While AEG was unable to access the Site to perform a close inspection of the observed potential sources of contamination, evidence of poor house keeping practices were observed and evidence of staining on the concrete pad is visible from the long range photos and video. The locations of the potential sources of contamination observed during the Site inspection, a description of the potential contaminant source, and the contaminants likely to be associated with the source are shown on **Figure 5**.

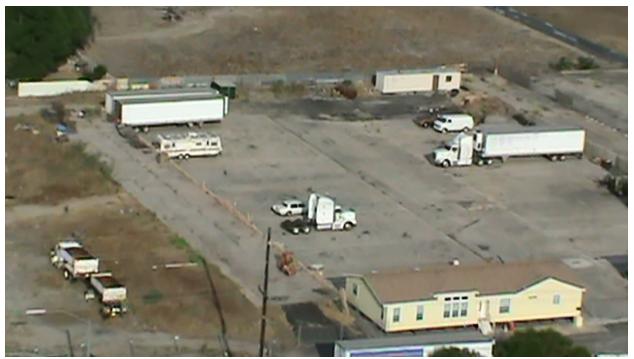
Picture 5 - Site Overview of Center, Looking East (Overview 4)

In the south center portion of the Site, (see **Overview Photos 4, 5,** and **6**) there are three semi truck trailers, two semi truck cabs, one RV, four automobiles, three fork lifts, two cargo containers, three steel tanks (one old and rusted and two newer), three drums, a pile of tires, a drum/AST storage compound, a portable restroom, and two buildings (not shown in overview photos).

The old steel tank is on the east side of the Site and may be the tank that was reported to have ruptured during the 2007 fire that burned the Site.

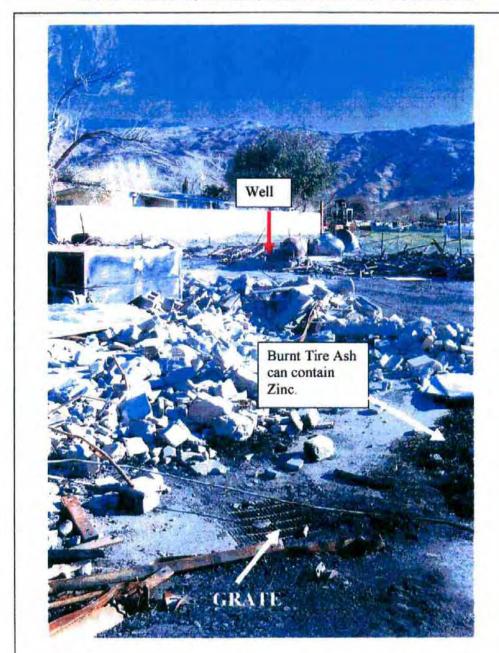
The grate covers a drain previously identified by EPA as an injection well that is regulated under the Underground Injection Control provisions of the Safe Drinking Water Act. If an underground tank does not capture whatever flows into the grate, contaminants will infiltrate through the soil into the groundwater.

Potential contaminant sources and paths for groundwater contamination through uncovered soil and the grate at the bottom of this photo: 3000 gallon dieser fuel tank with no containment Pamp Burn **GRATE** - See page 2 picture caption

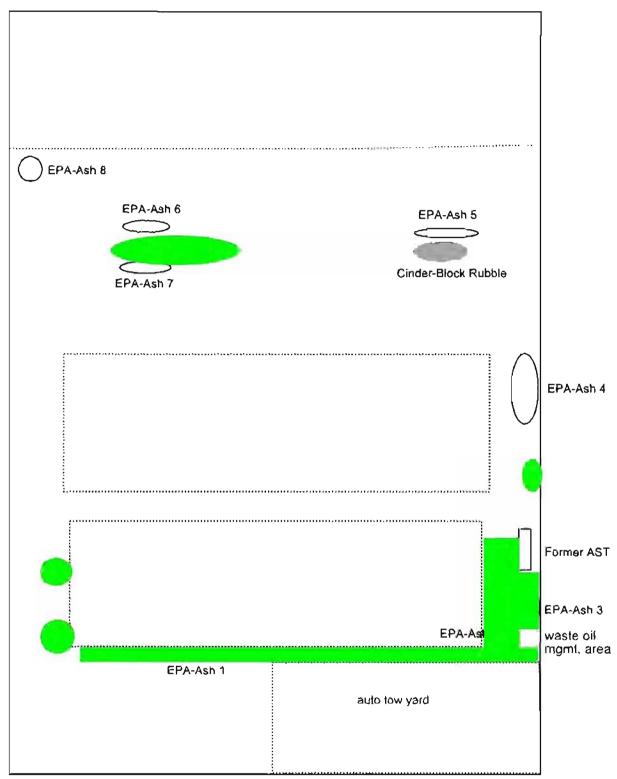
Figure 4
Areas of Contaminated Soil and Ash Removal
August 22, 2008
33777 Valley Center Road
Valley Center, California

Areas of Removal and XRF Confirmation Analysis

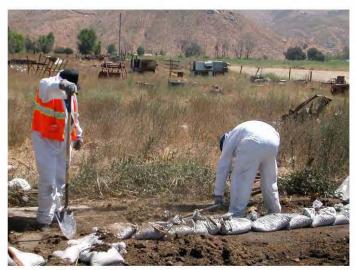
### PHOTOGRAPH 2:

Envirosery personnel removing TPH-contaminated soil to the south of the waste oil management area.

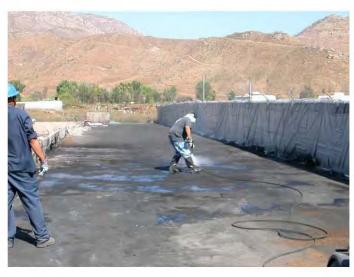
### PHOTOGRAPH 3:

Pressure-washing "driveway" area after sweeping up the ash.

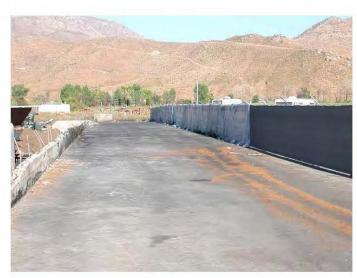
### PHOTOGRAPH 5:

"Driveway" area, after XRF confirmation analysis.
